RE: Southern Cove Closure Report

The Department has reviewed the Southern Cove Closure Report dated January 11, 2018. This report details the Corrective Measures performed during the period of July 5 – November 27, 2017 at the Southern Cove site in Orrington, Maine.

**Subject: Southern Cove Closure Report  
Orrington Remediation Site  
Orrington, Maine**

## **Southern Cove** Construction Closure Report Orrington Remediation Site Orrington, Maine

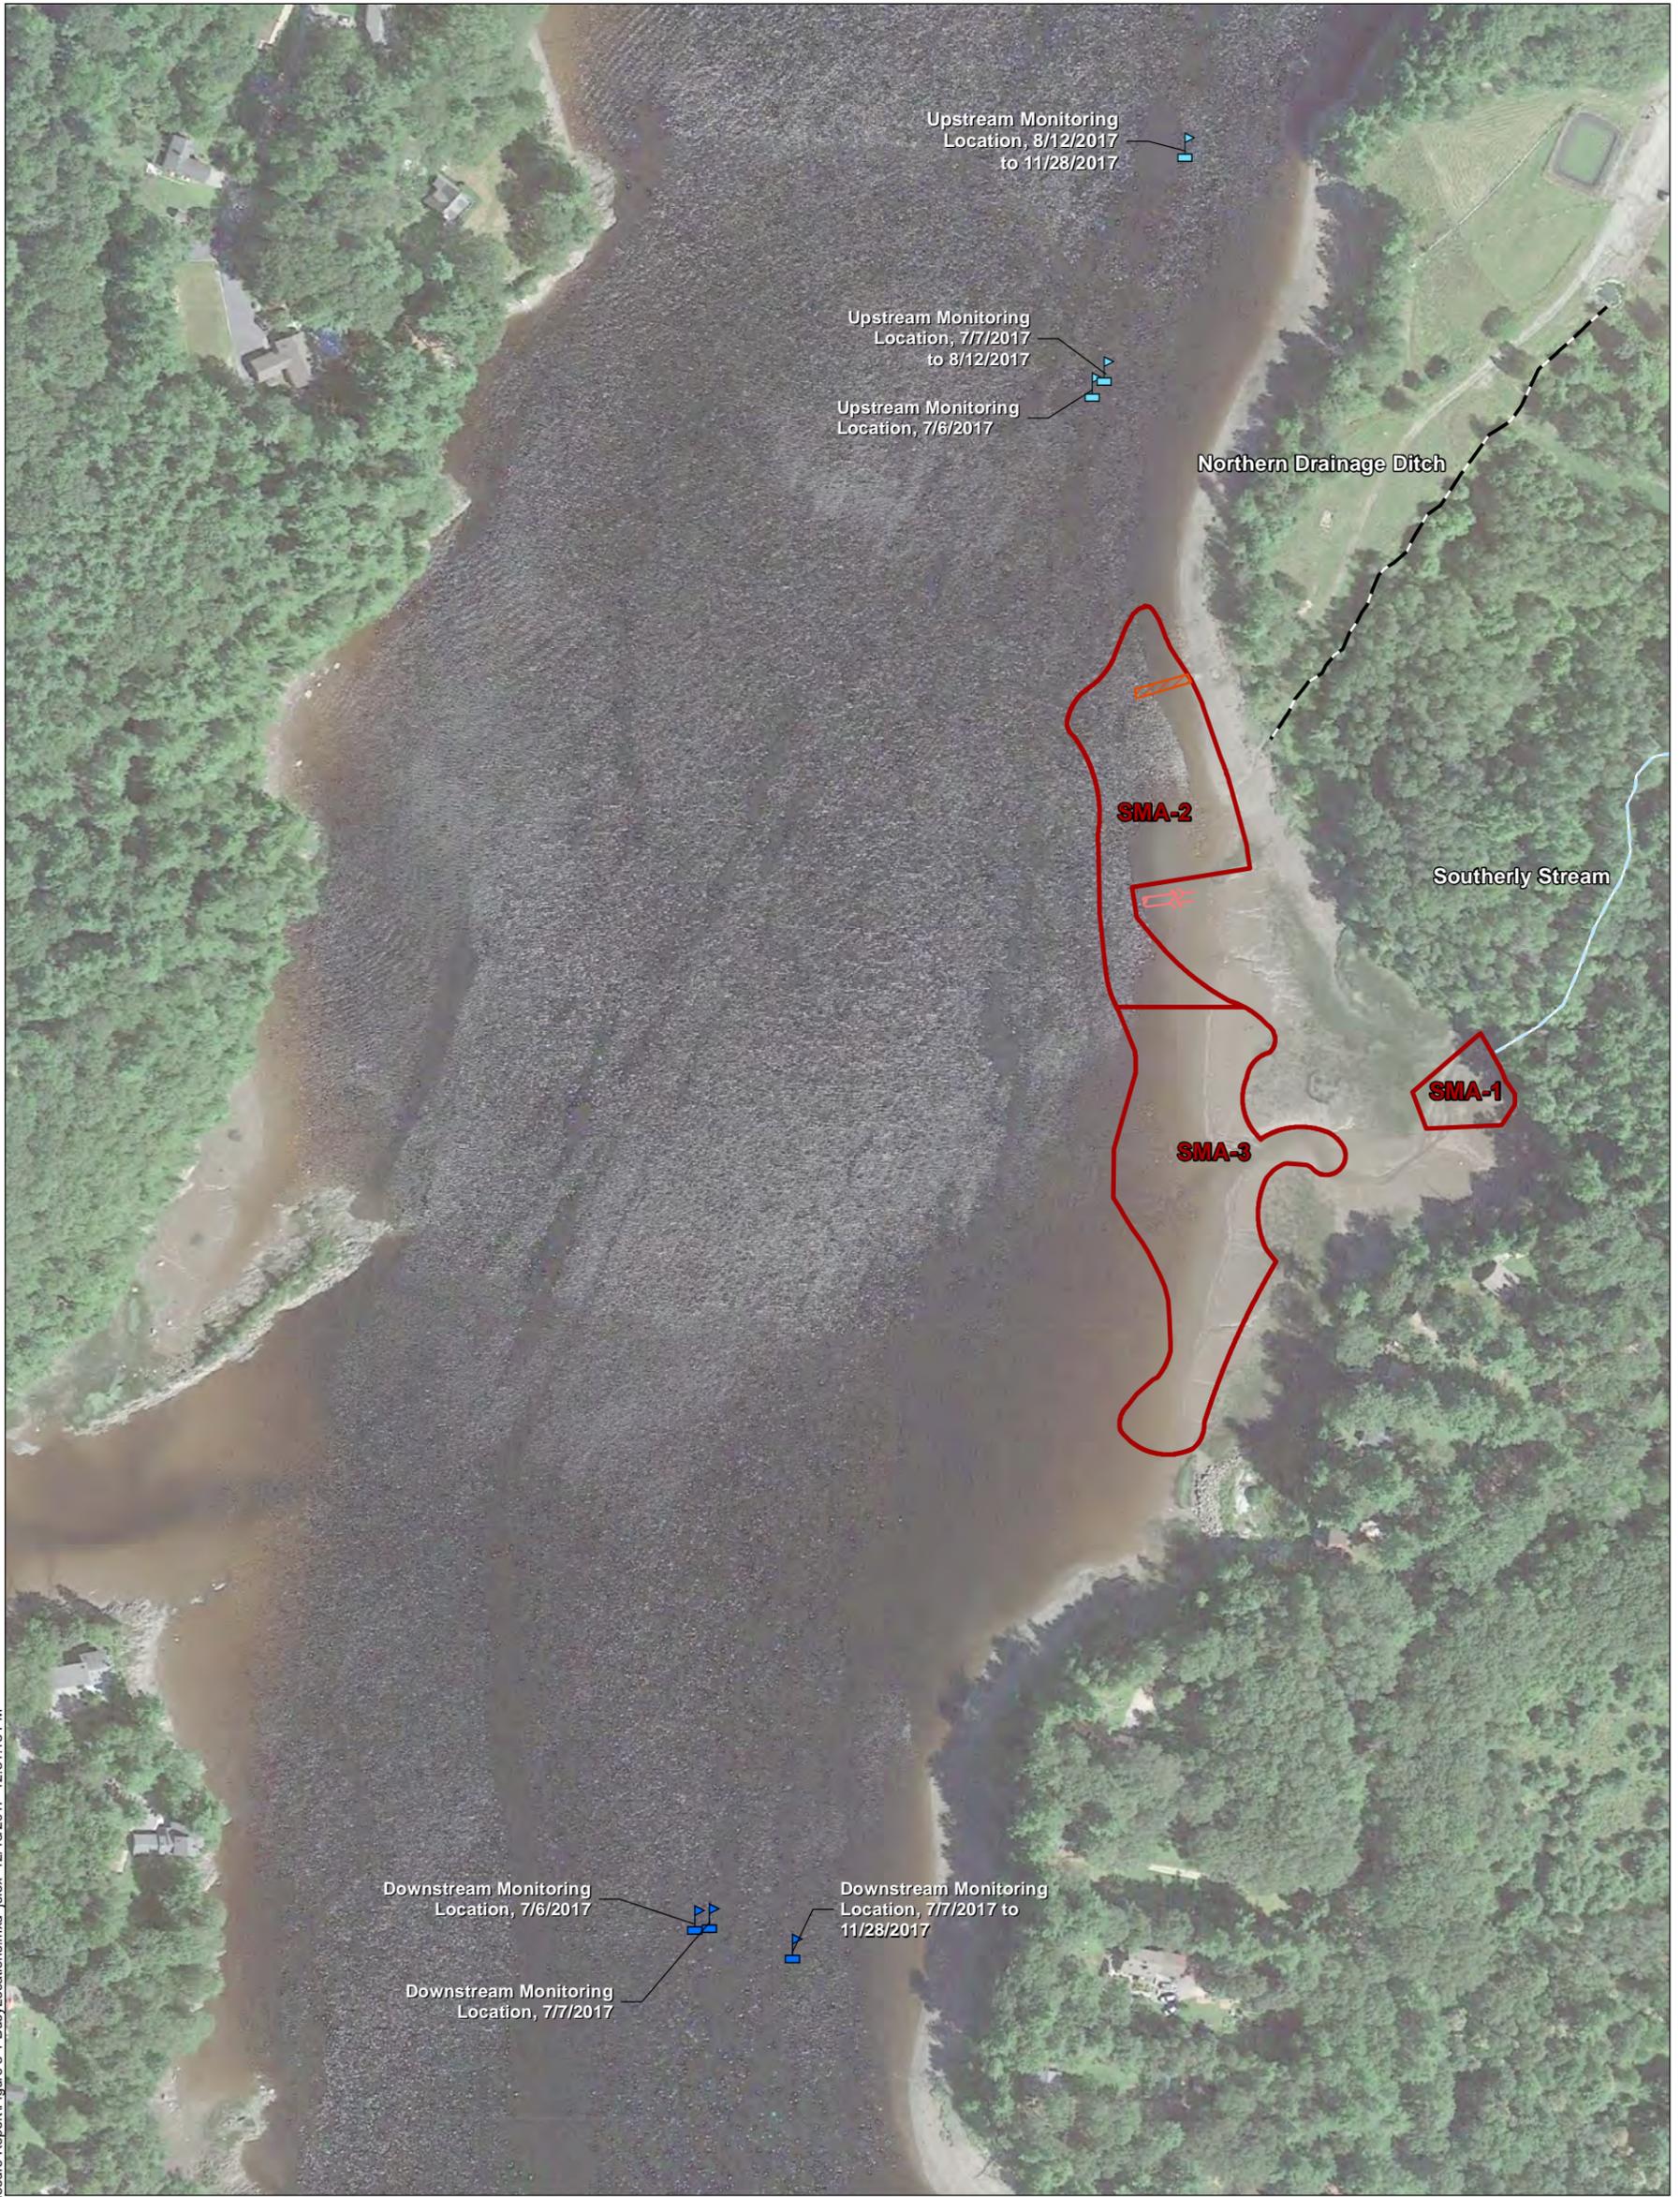
**Figure 3-1**  
Water Quality Monitoring Buoy Locations  
Construction Closure Report  
Southern Cove, Orrington Remediation Site

Throughout the duration of water quality monitoring, turbidity measurements were heavily influenced by the tide cycle. Elevated turbidity levels were typically measured around low tide and approximately 90 minutes prior to high tide. These elevated measurements were observed both prior to and throughout the duration of removal and backfill placement operations. Exceedances of the water quality criteria were noted at regular intervals during in-water work, but these exceedances were observed at times that generally coincided with natural fluctuations caused by the tide cycle. Elevated turbidity levels measured during the in-water work generally coincided with the natural tide cycle as observed prior to the in-water work, and the on-site CQA Engineer did not observe visible turbidity plumes leading from the work area to the monitoring buoys. Thus, the CQA Engineer concluded that these elevated measurements were unrelated to the Contractor's operations. No exceedances were noted during the in-water work that were attributable to the Contractor's operations.

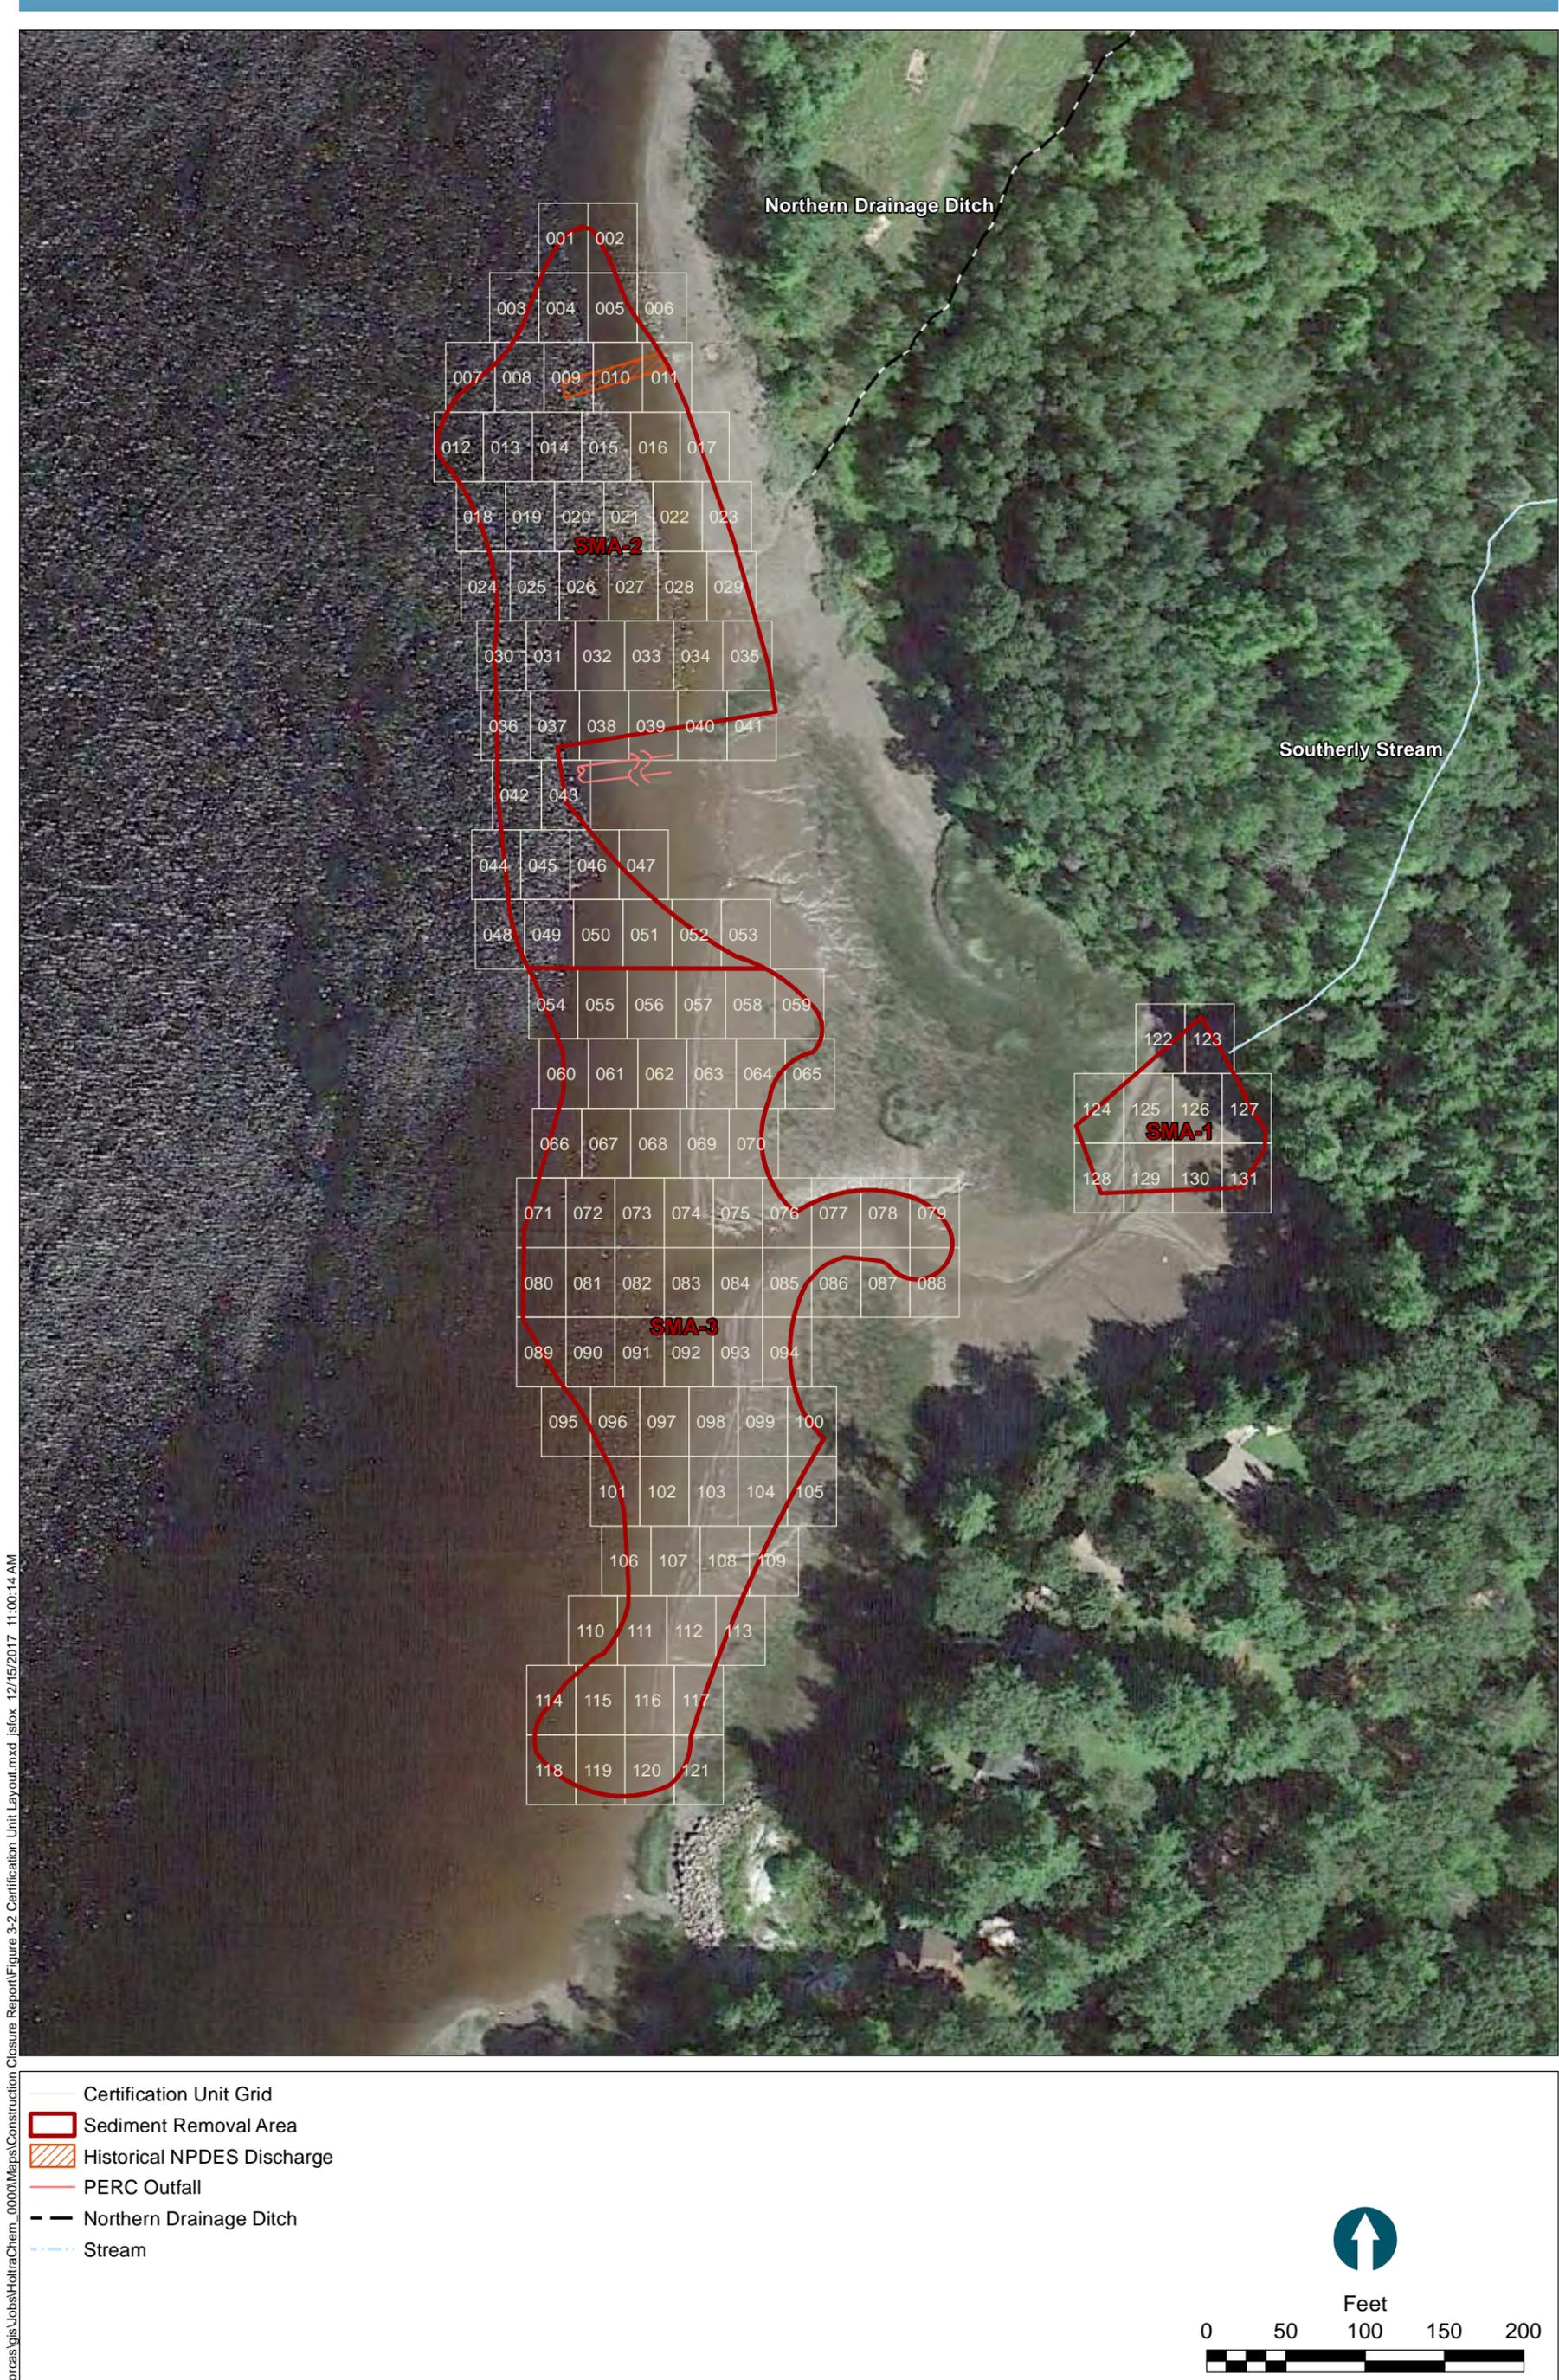
**Figure 3-2**  
 Certification Unit Layout  
 Construction Closure Report  
 Southern Cove, Orrington Remediation Site

- Post-removal (post-dredge/excavation) surveying to verify required removal elevations were achieved
- Collection of confirmation samples following completion of sediment removal within a Certification Unit (CU)

Following the completion of sediment removal within each CU, a confirmation sample was collected in accordance with the Confirmation Sampling Protocol in Appendix H of the CMI Plan. If excavation of the CU was completed in the dry, the confirmation sample was collected by hand using stainless steel hand tools (**Appendix B**, Photograph 31) by the CQA Engineer or designee. If removal of the CU was completed in the wet, the confirmation sample was collected using a pneumatically-powered power grab sampler (**Appendix B**, Photograph 32). If the power grab sampler was unable to collect a sample after two attempts, then no removable sediment was assumed to be remaining at that location and further attempts to collect a sample were discontinued.

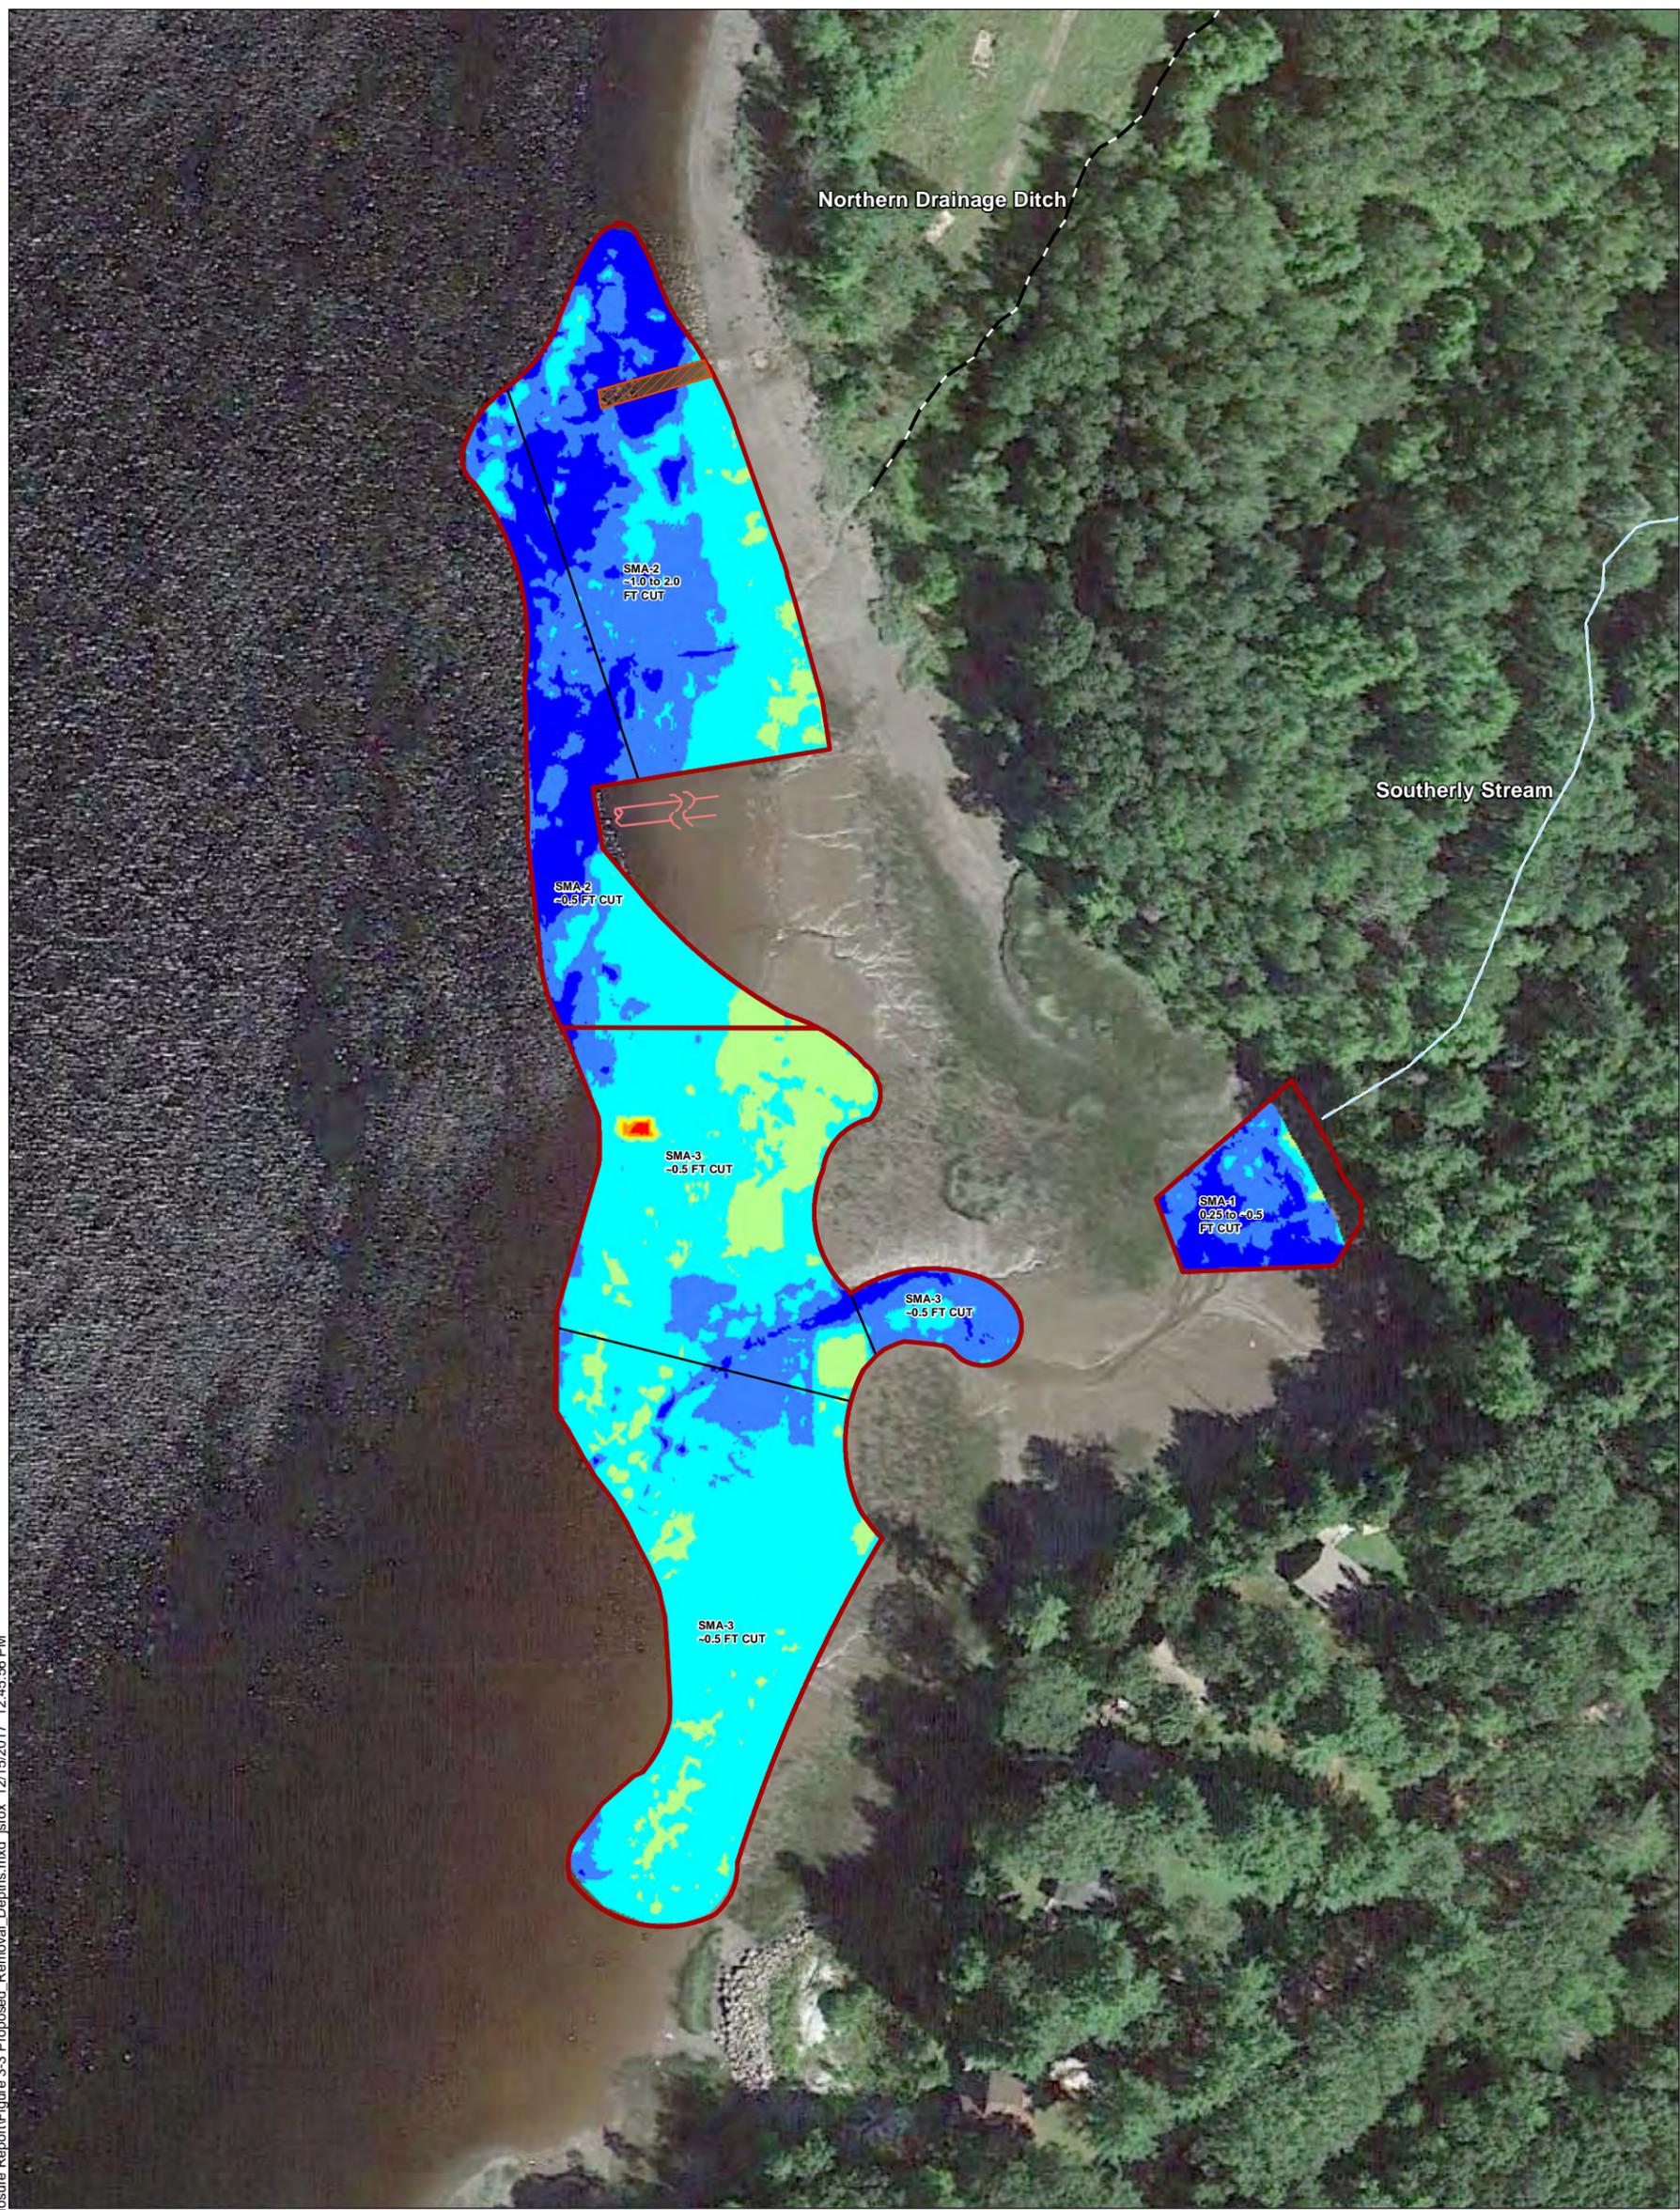
**Figure 3-3**  
Sediment Removal Areas and Thicknesses  
Construction Closure Report  
Southern Cove, Orrington Remediation Site

The CMI Plan outlines details for the removal of sediment with mercury concentrations above the MPS (2.2 milligrams per kilogram [mg/kg] for mercury), backfill, and restoration of the Southern Cove. Remedial construction in the Southern Cove area included the following primary components in the general order in which they were executed:

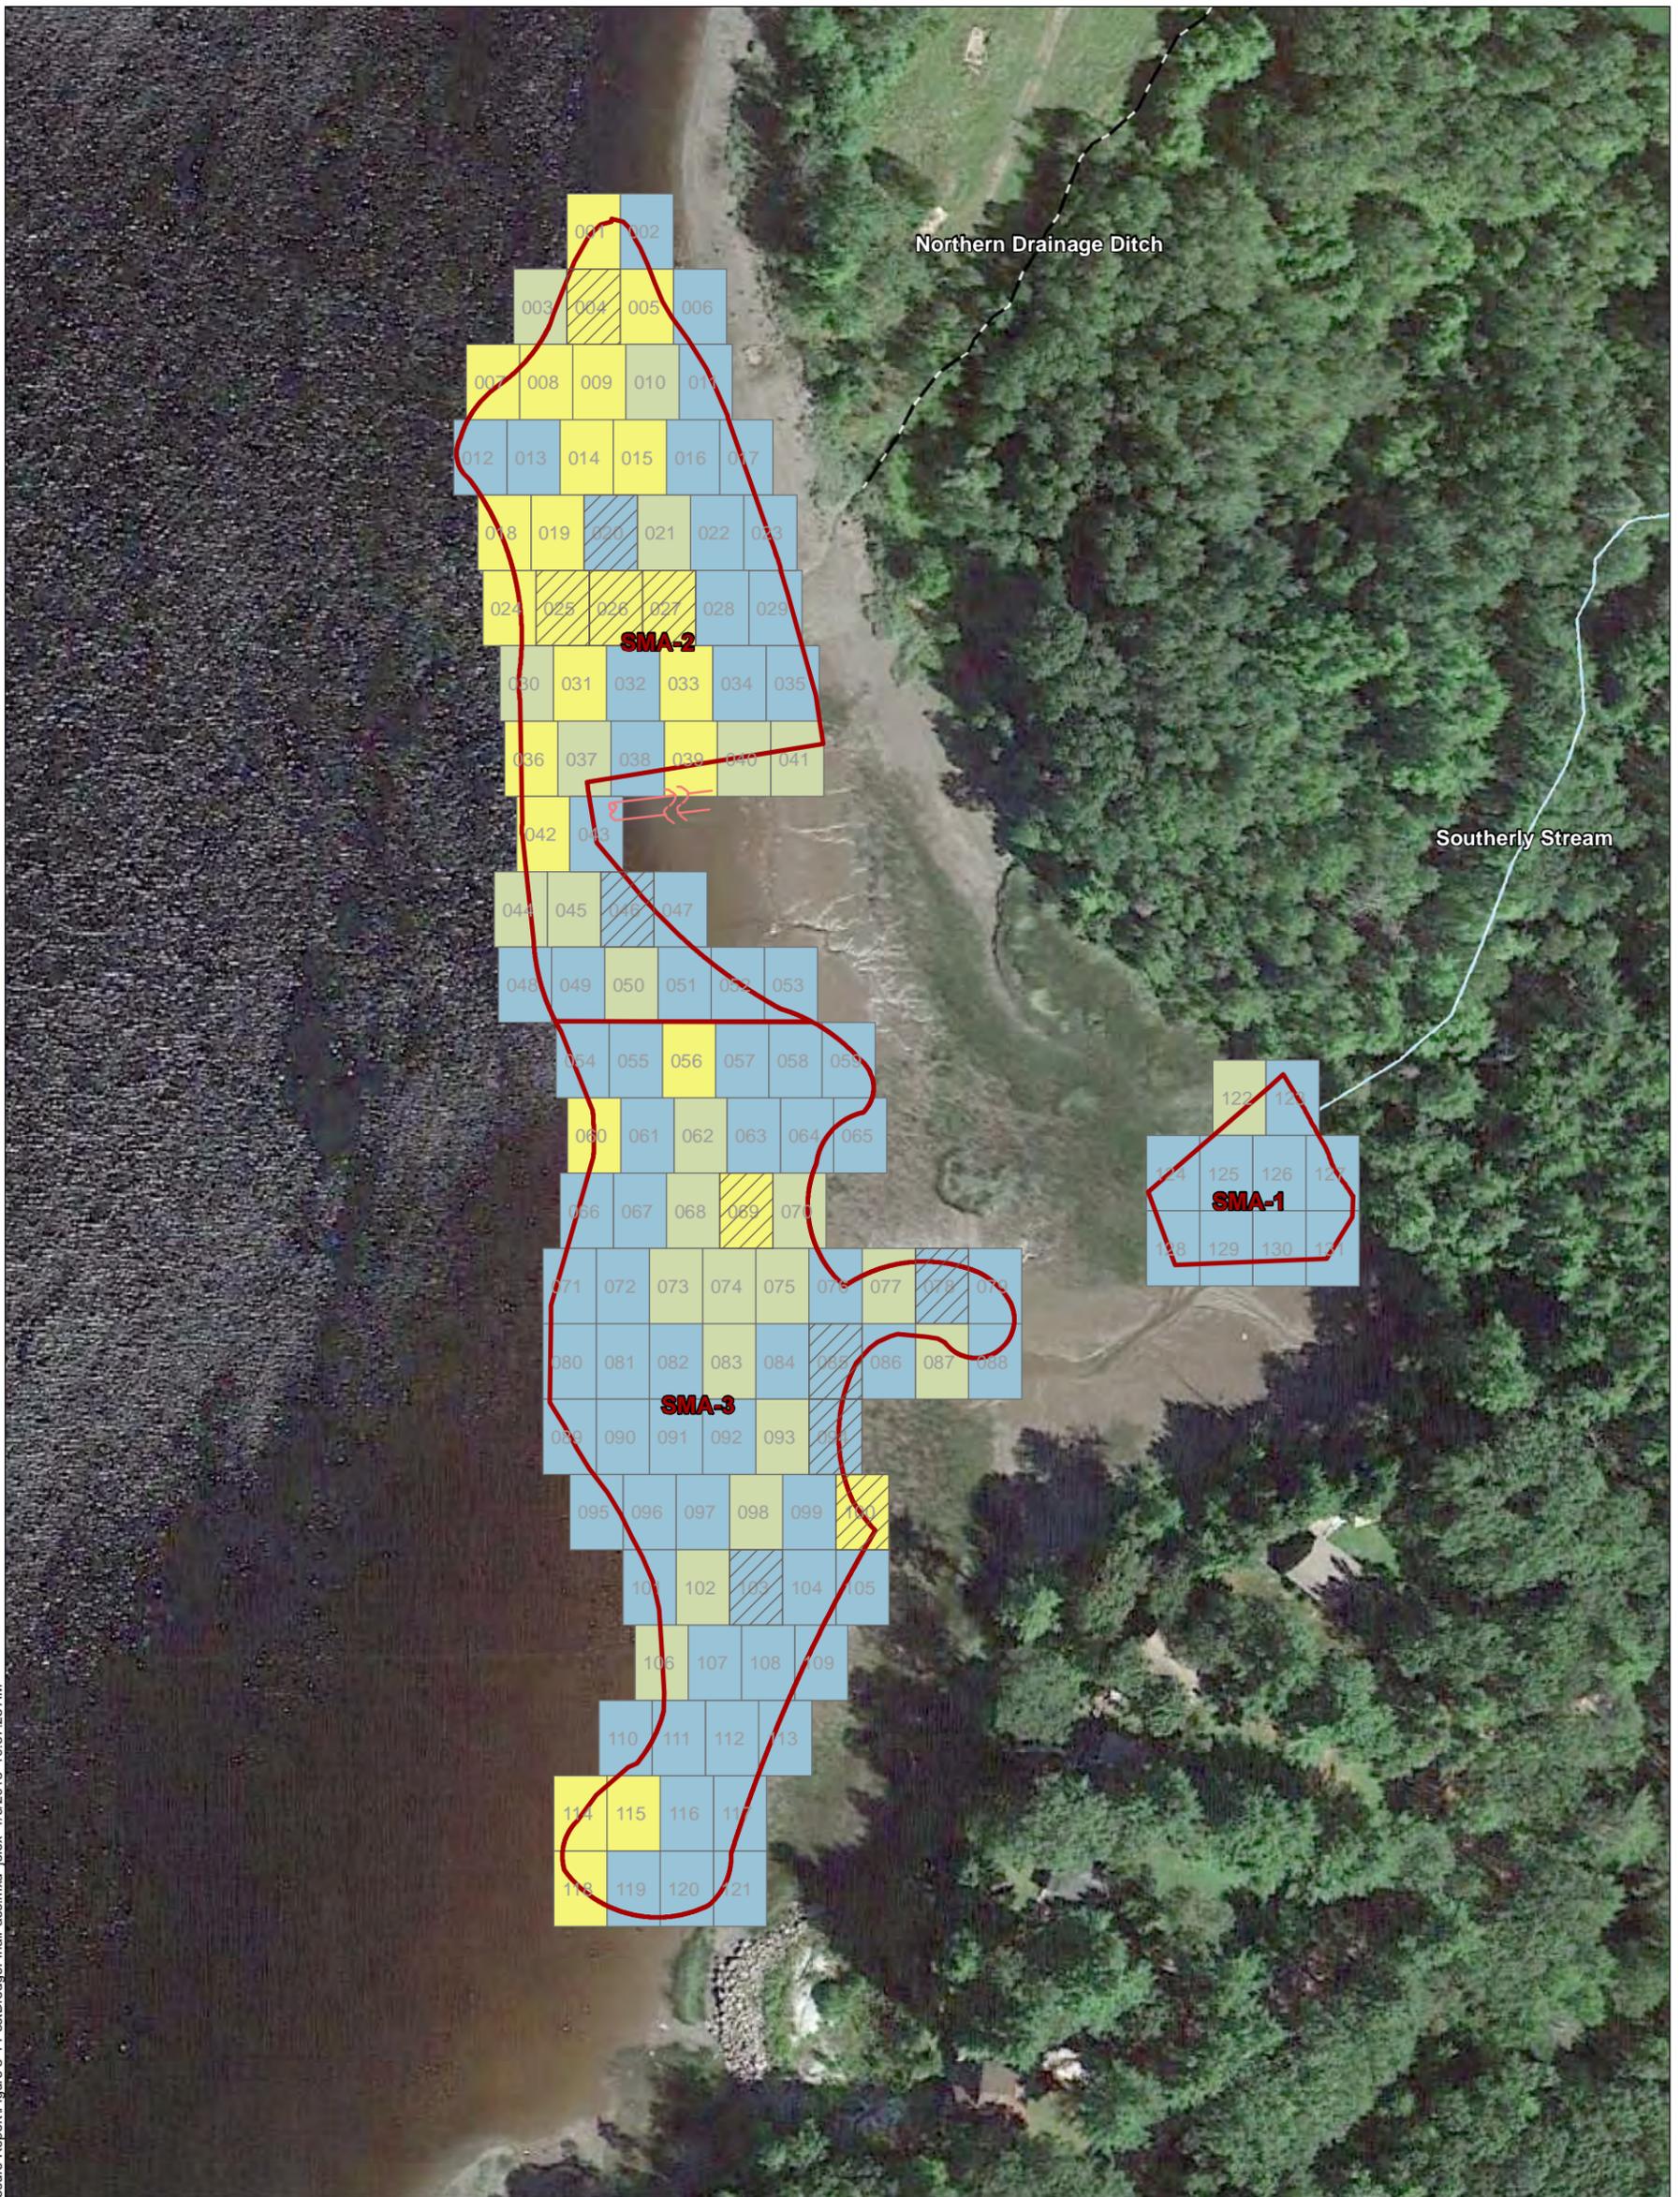
**Figure 3-4**  
 Post-Removal MPS Compliance Evaluation Summary  
 Construction Closure Report  
 Southern Cove, Orrington Remediation Site

The first step of survey verification was to establish if the required removal depth was met. Compliance with the design was based on achieving the required grade across at least 90% of the CU, excluding locations where rock or clay (i.e., hard subgrade) constrained the depth of removal. Hard subgrade was noted by the surveyor during post-removal survey data collection. In addition to achieving the required grade over 90% of the CU, the following additional requirements applied:

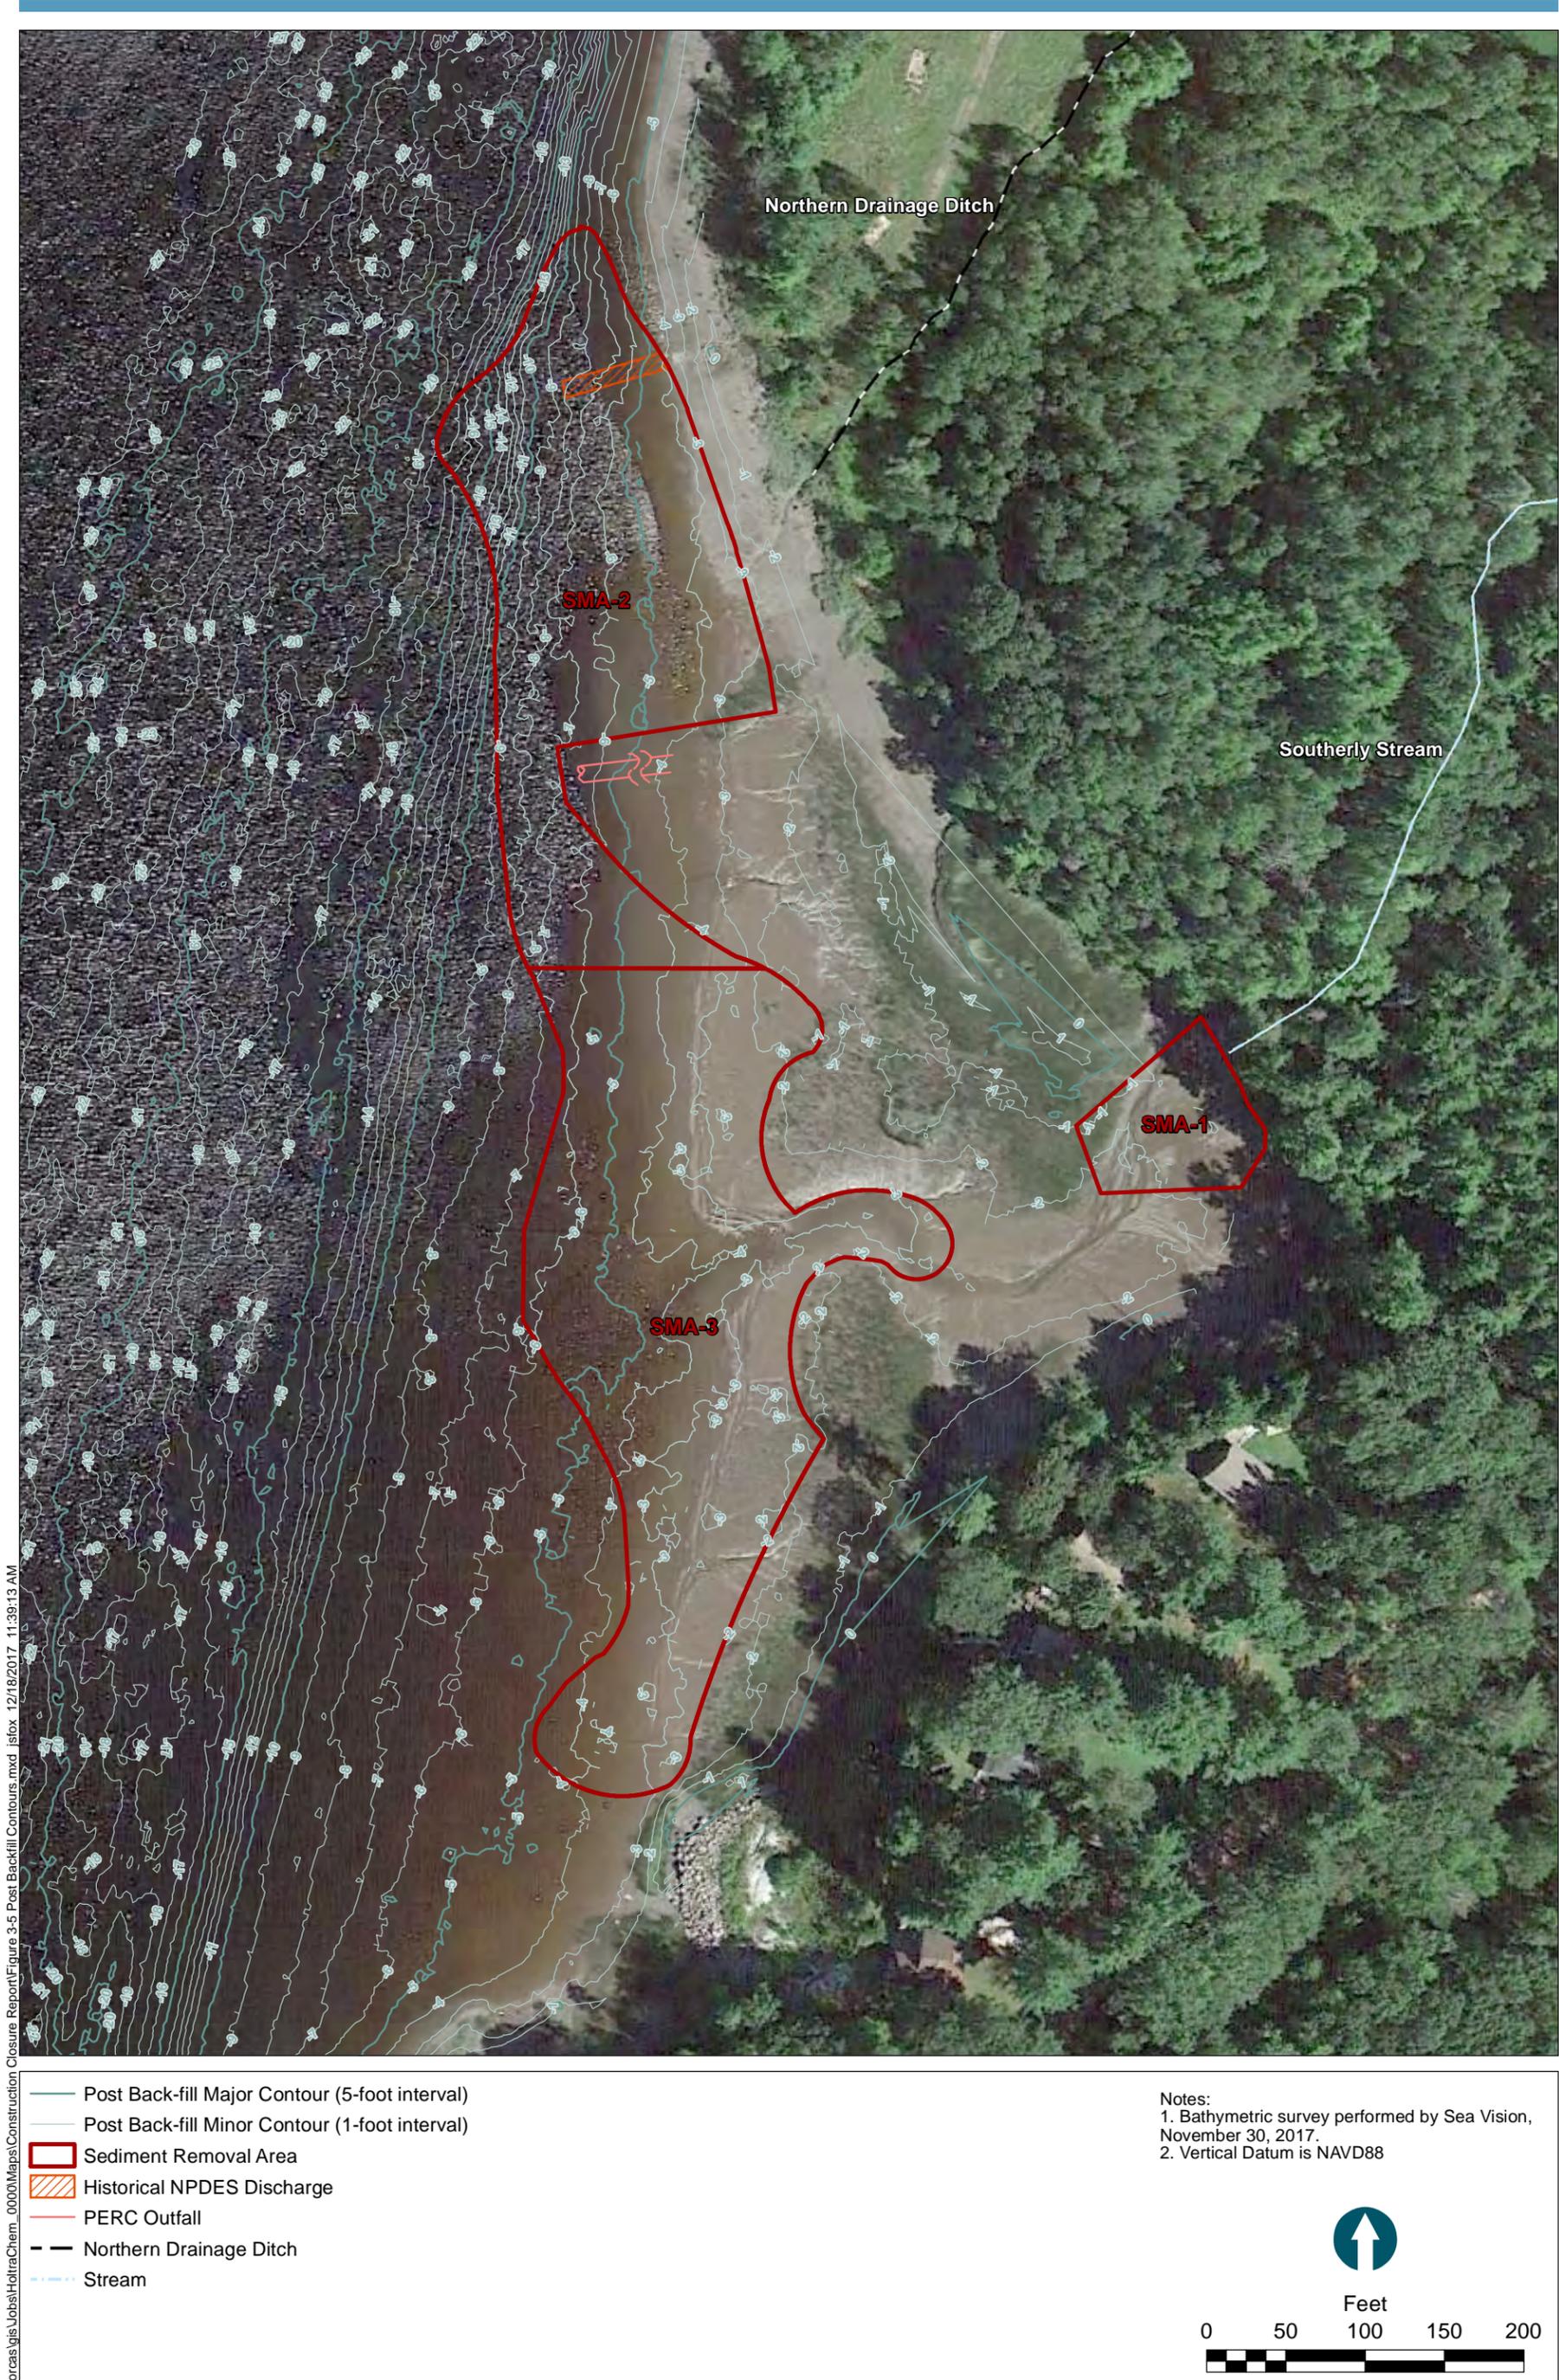
**Figure 3-5**  
 Post-Backfill Bathymetric Contours  
 Construction Closure Report  
 Southern Cove, Orrington Remediation Site

- Placement of final backfill over SMA-2 and SMA-3 after all removal and initial lift backfill was completed
- Post-backfill surveying to verify removal areas had been returned to pre-construction grades

An initial backfill lift of approximately 6 inches was placed following acceptance of the required removal within a CU (as described in Section 3.6) and prior to moving the mobile turbidity curtain system to the adjacent CU. After all sediment removal and initial lift backfilling was completed, final backfill was placed to the required grade to approximate pre-removal conditions over SMA-1, SMA-2, and SMA-3. The following QA/QC steps were performed relative to backfilling:
